Docket No. 217 – Development and Management Plan Inspection

Northeast Utilities Service Company Certificate of Environmental Compatibility and Public Need for the construction of a 345-kV electric transmission line and reconstruction of an existing 115-kV electric transmission line between Connecticut Light and Power Company's Plumtree Substation in Bethel, through the towns of Redding, Weston, and Wilton, and to the Norwalk Substation in Norwalk, Connecticut.

Date: November 23, 2005

Location: 345kV Underground Route

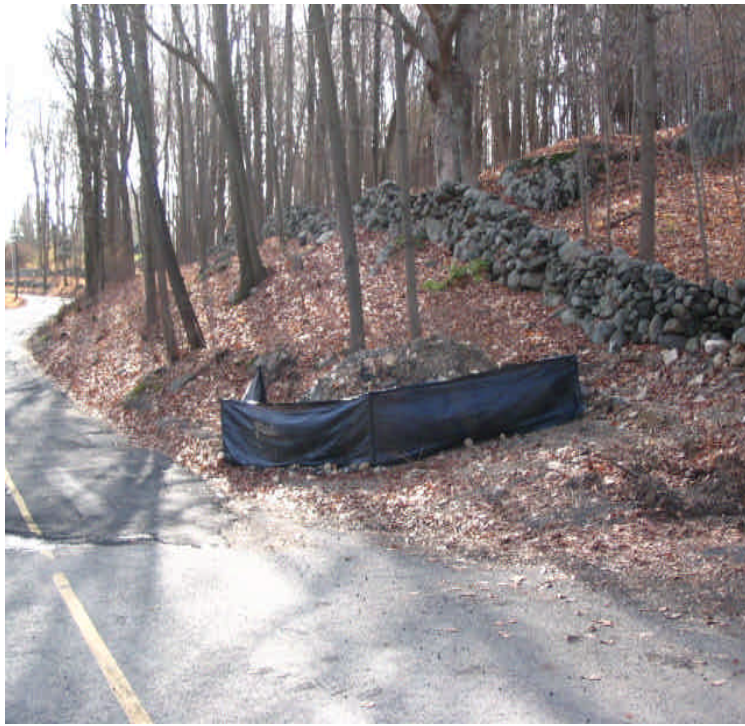
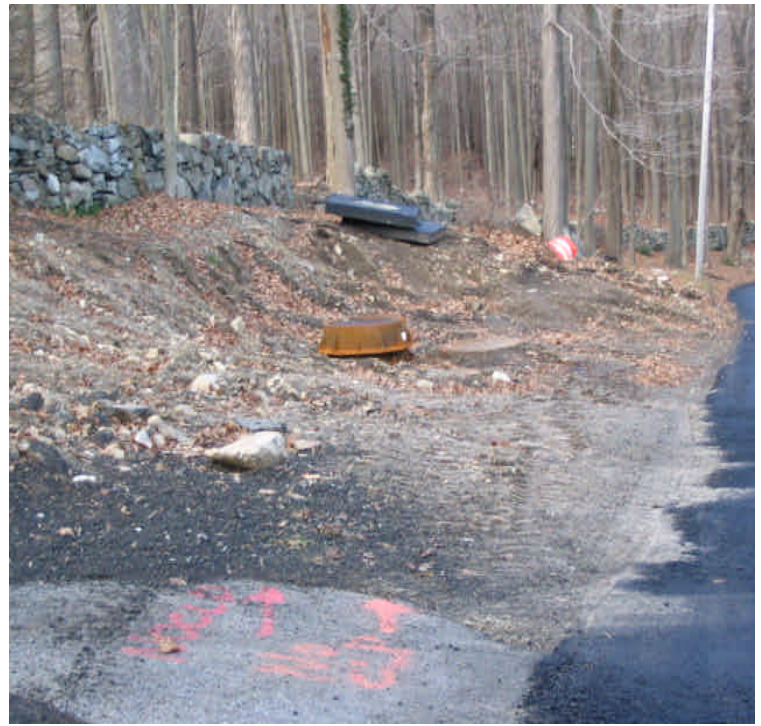
345kV (Umpawaug Rd Daywork): The photo on the left shows a stockpile left near the Diamond Hill Rd. end with silt fence installed as recommended. The photo on the right shows a vault in the same general area that needs some restoration. 11/23/05

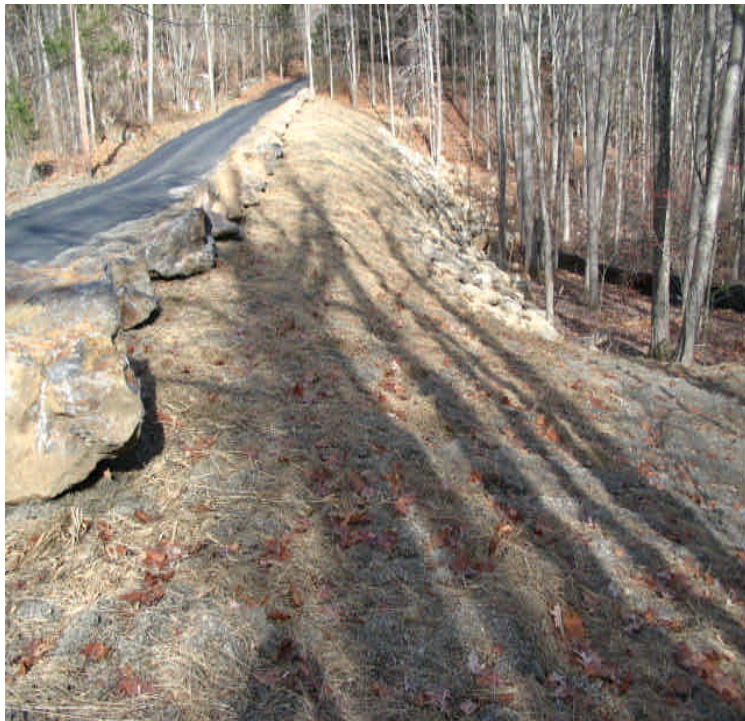
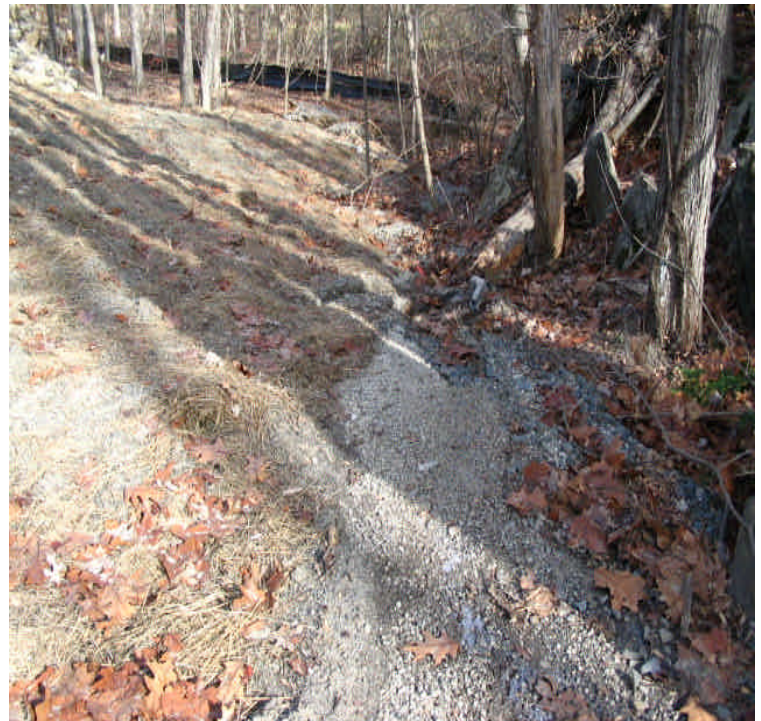
Photo on the left shows the large slope where mulch was applied. Photo on the right shows where some stormwater has created some erosion along the edge of the slope. A haybale here may help the situation. 11/23/05

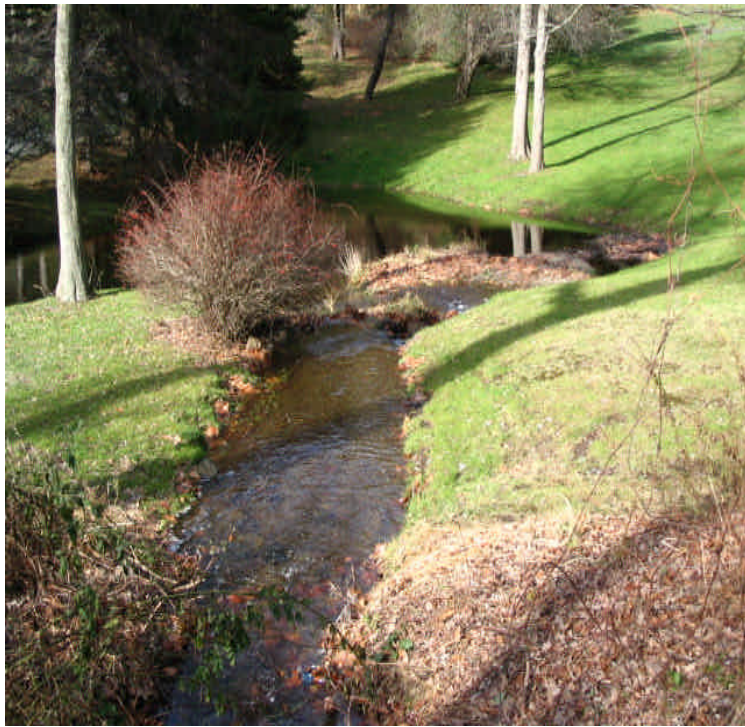
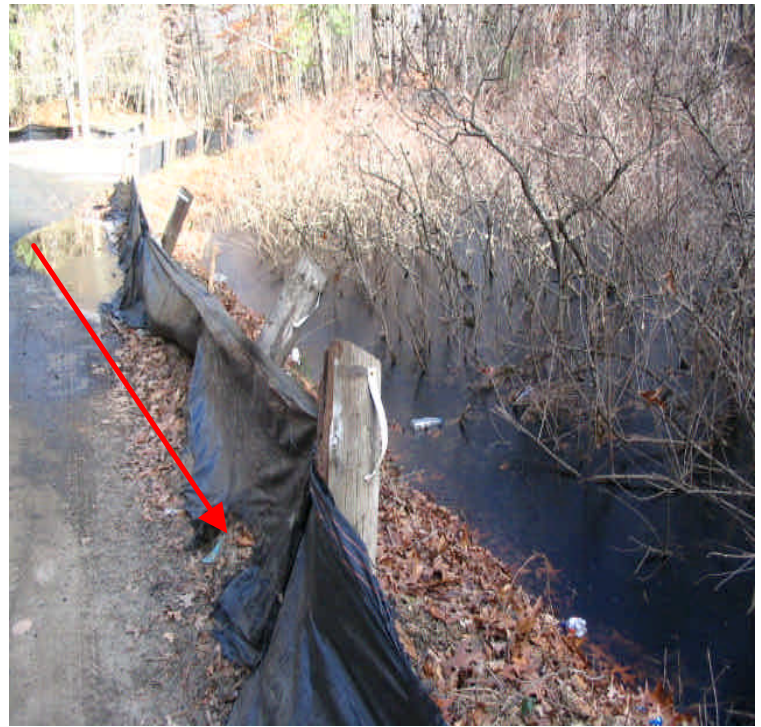
Photo on the left shows the pond near Parsons Lane which is clear at this time following the turbidity event noted a few weeks ago. Photo on the right shows wetlands in the vicinity of Wayside Lane. Erosion controls are becoming worn in a few locations. 11/23/05

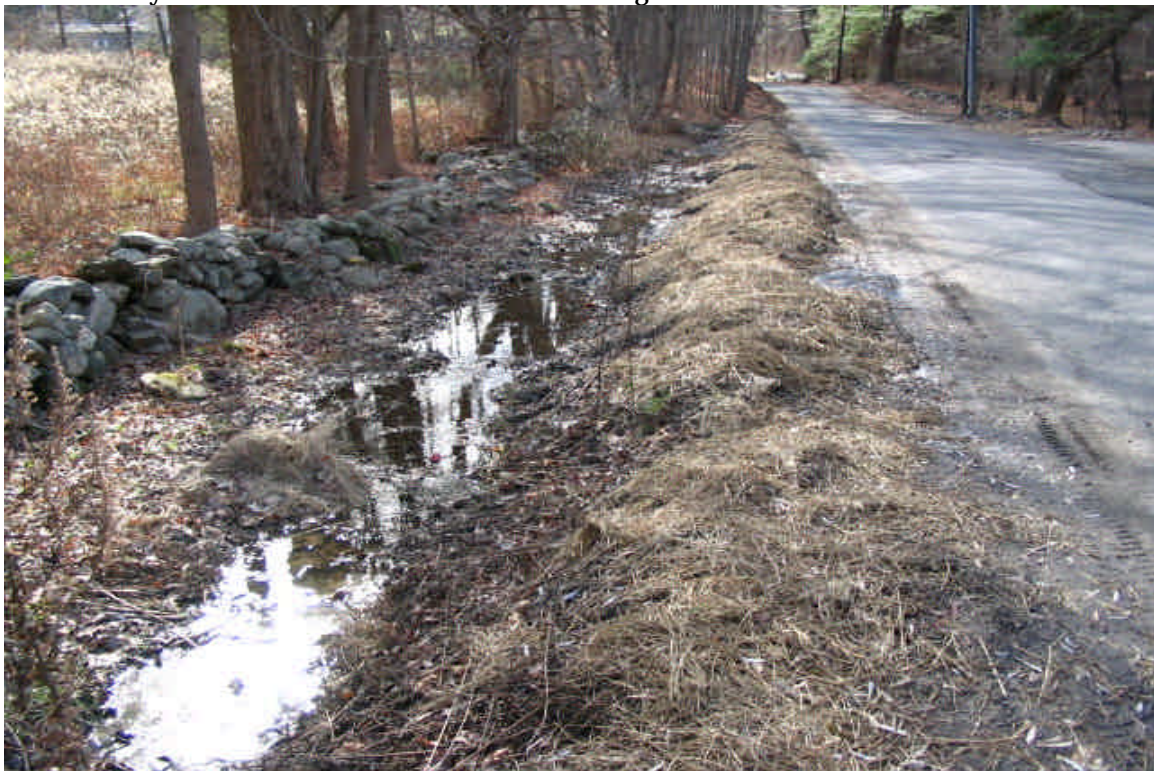
View of the restoration of the wetland swale leading to the stream to the pond near Parsons Lane. Contours of the swale were re-created appropriately and the area was mulched. A haybale check dam remains in place. 11/23/05

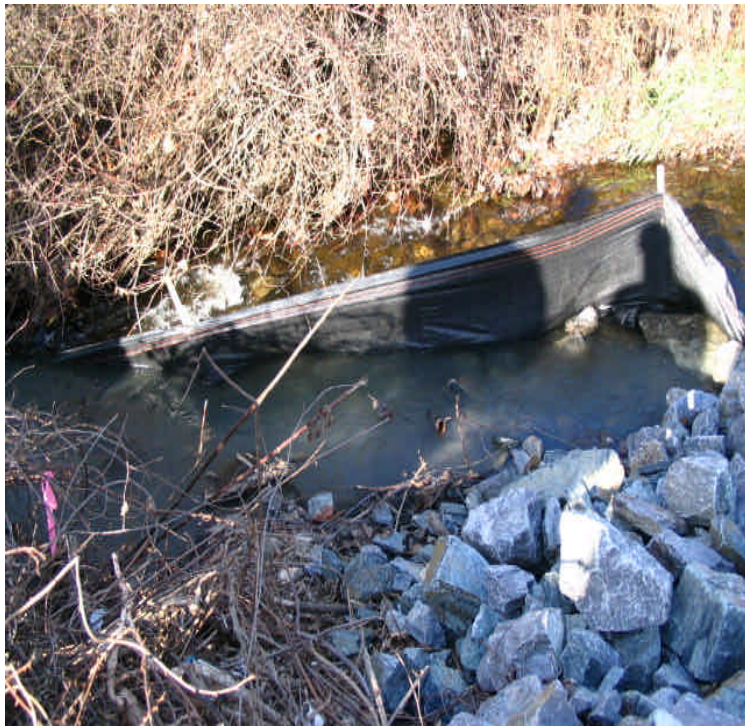
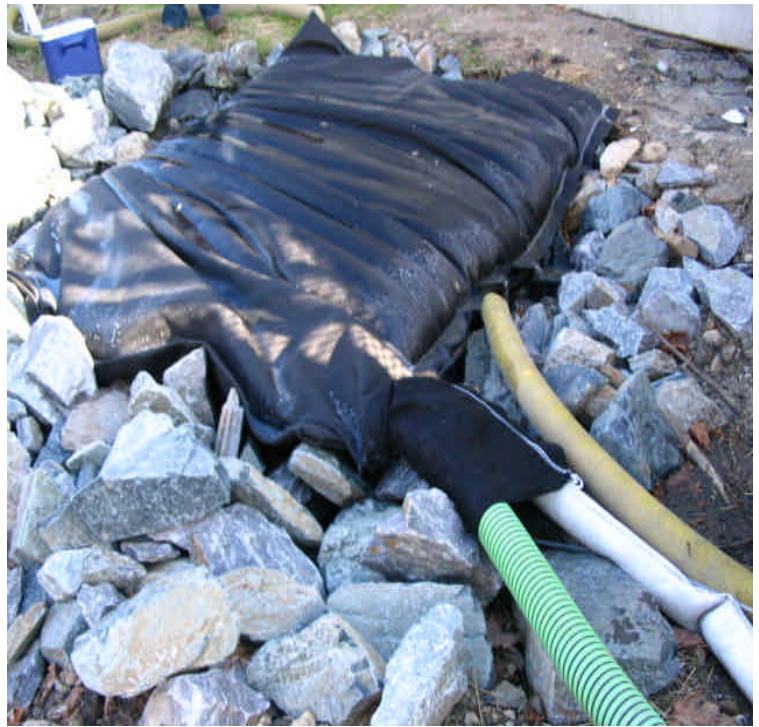
345kV (Route 107- Georgetown Jack and Bore): Photo on the left shows the high water level of the stream with the silt fence helping to control a small amount of turbidity created during a filter change. Photo on the right shows a filter bag in place at the discharge point. 11/23/05

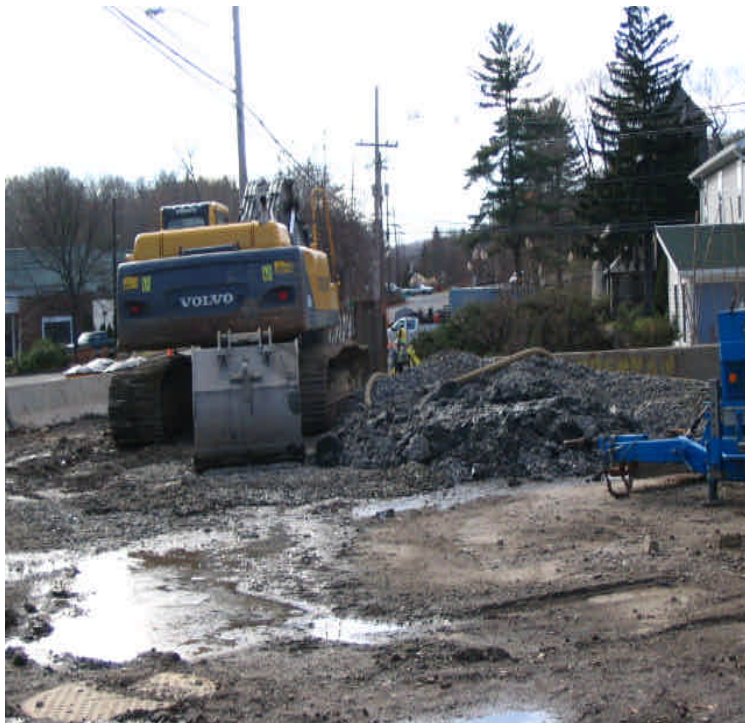
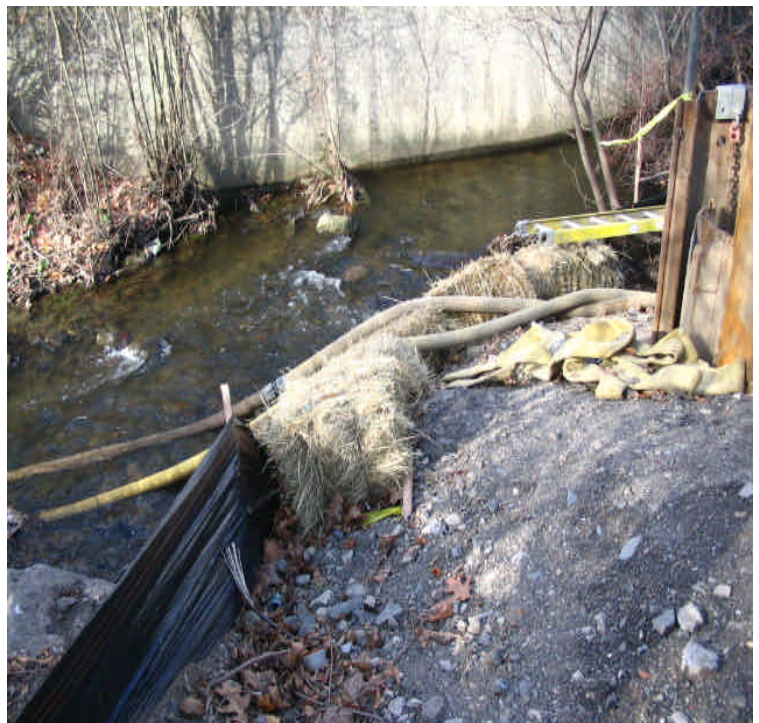
Photo on the left shows a general overview of the Georgetown Deli site. Photo on the right shows the stream adjacent to the jacking pit with erosion controls. The stream is running fairly clear at this point 11/23/05

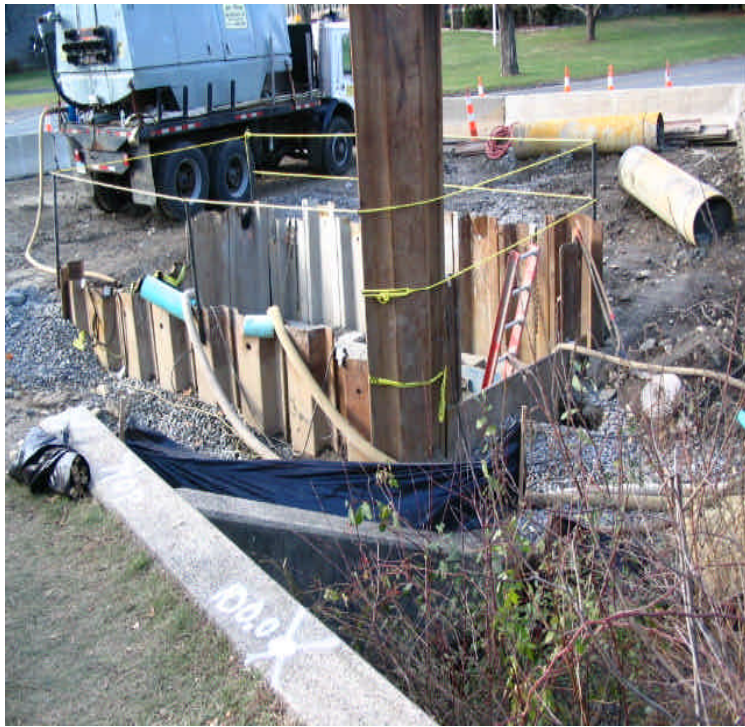
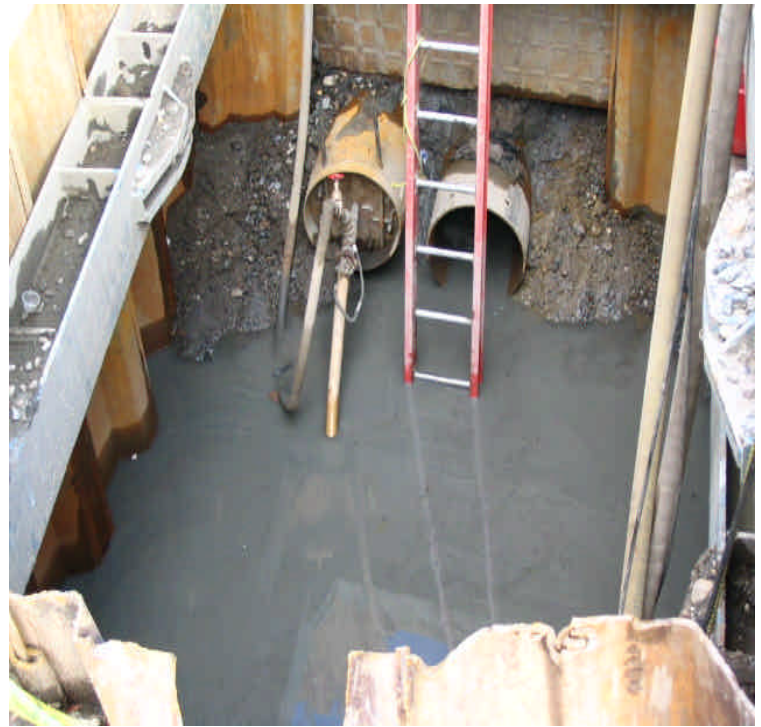
Photo on the left shows the receiving pit with good erosion controls and filtration. Stone and haybales were placed adjacent to the stream. Photo on the right shows a view into the pit where the conduit pipe is in place. The HPFF pipe still needs to be placed through. 11/23/05

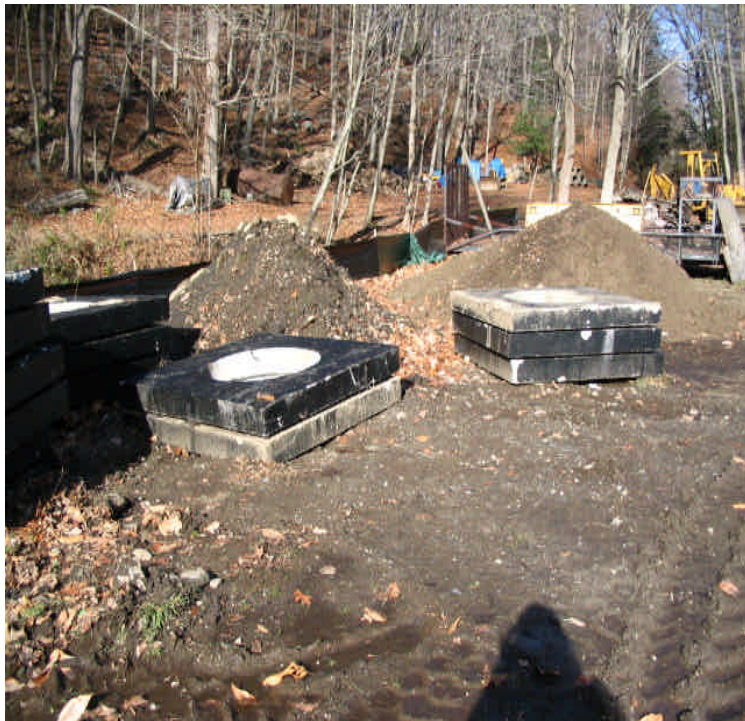
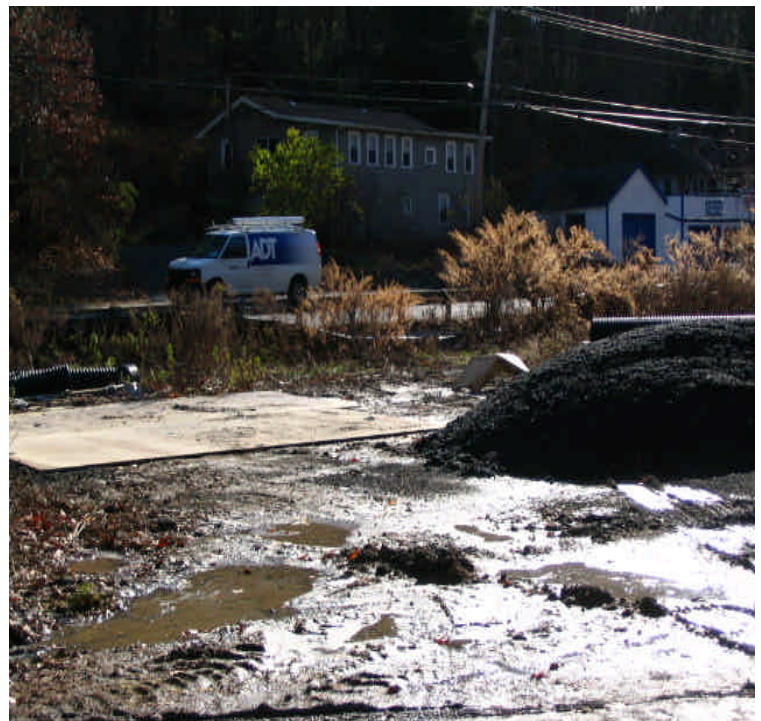
345kV (Storage Area Rt. 7/107): Photo on the left shows the silt fence with stockpiles adjacent. The fence remains in place here and some of the activities are the landowners. Photo on the right looks toward Rt. 7 where a wetland swale is adjacent. Take care to keep this area contained from the yard. 11/23/05

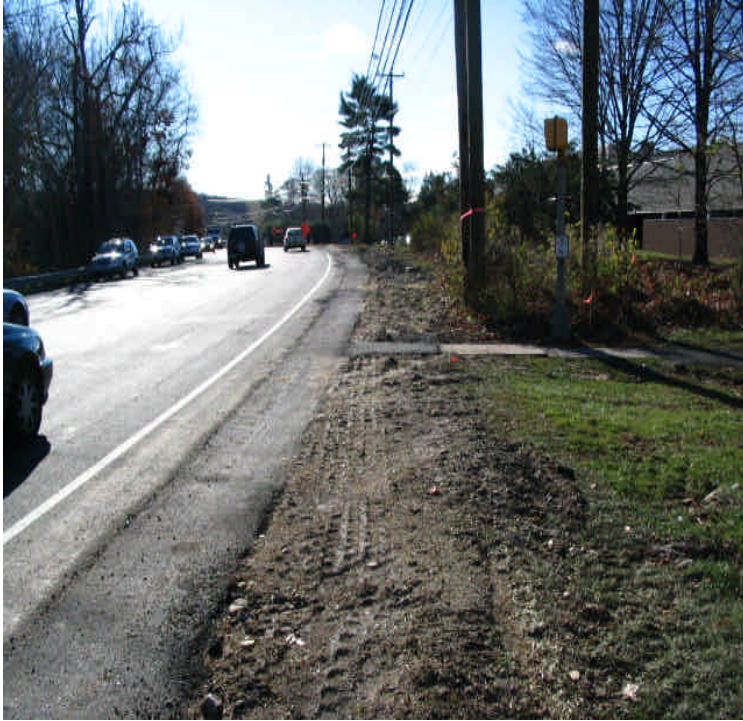
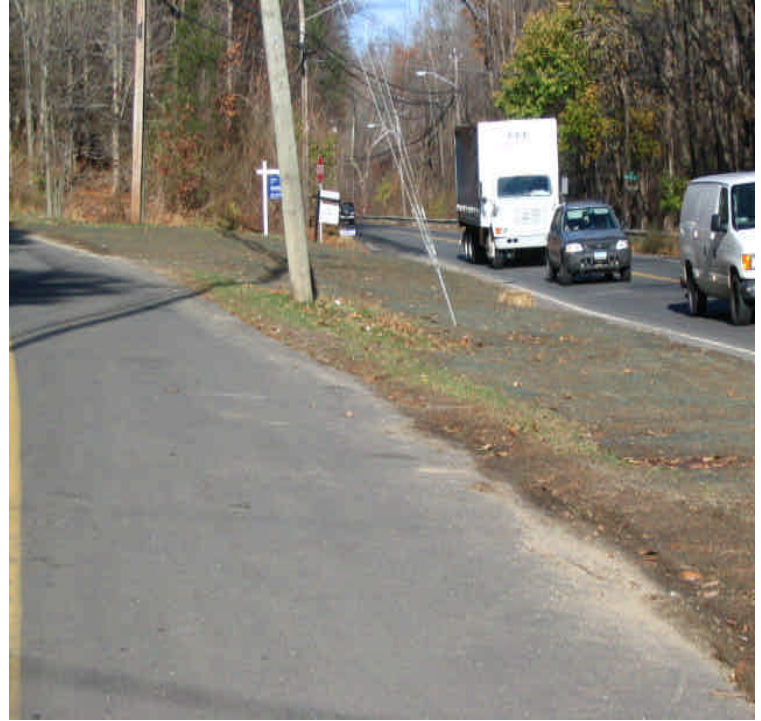
345kV (Rt 7): Photo on the left shows a view towards Catalpa Rd. where work has been recently. Areas should be restored when feasible. Photo on the right shows good restoration with hydroseed in the vicinity of Scribner Hill Rd. 11/23/05

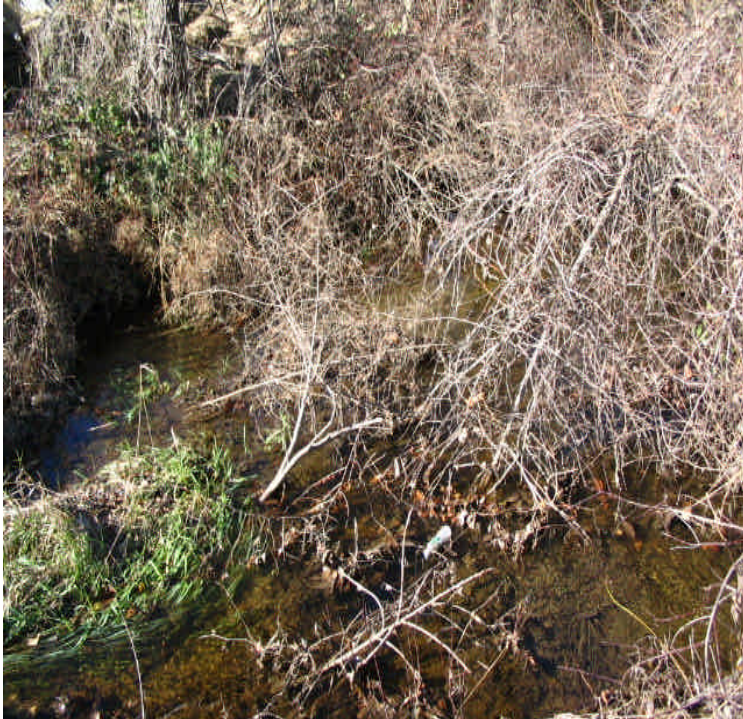
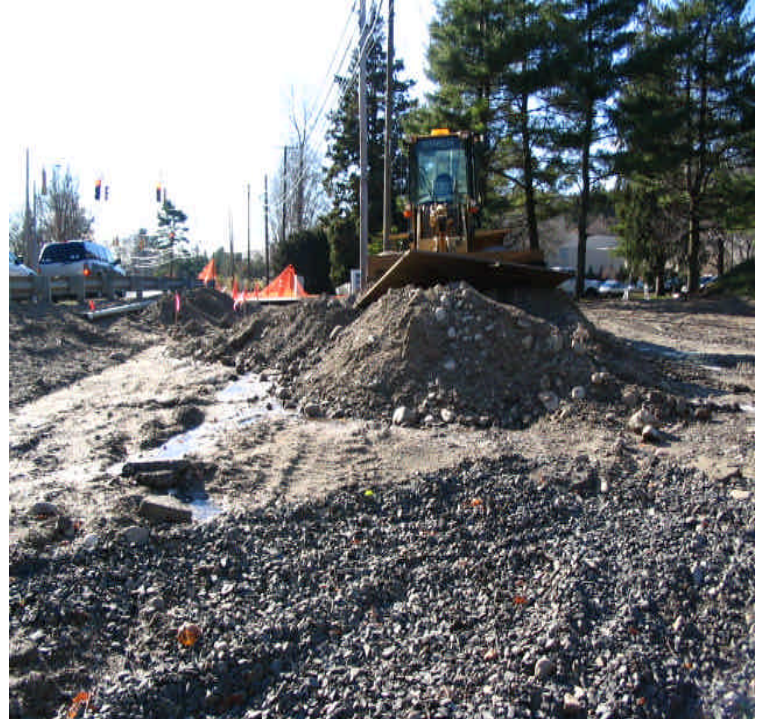
345kV (Wilton HS J&B): Photo on the left shows the stream which had several areas of accumulated sediment that should be removed to restore the stream to original conditions. Photo on the right shows some additional earthwork likely part of the town sewer project here although Kemsco equipment was on site. 11/23/05

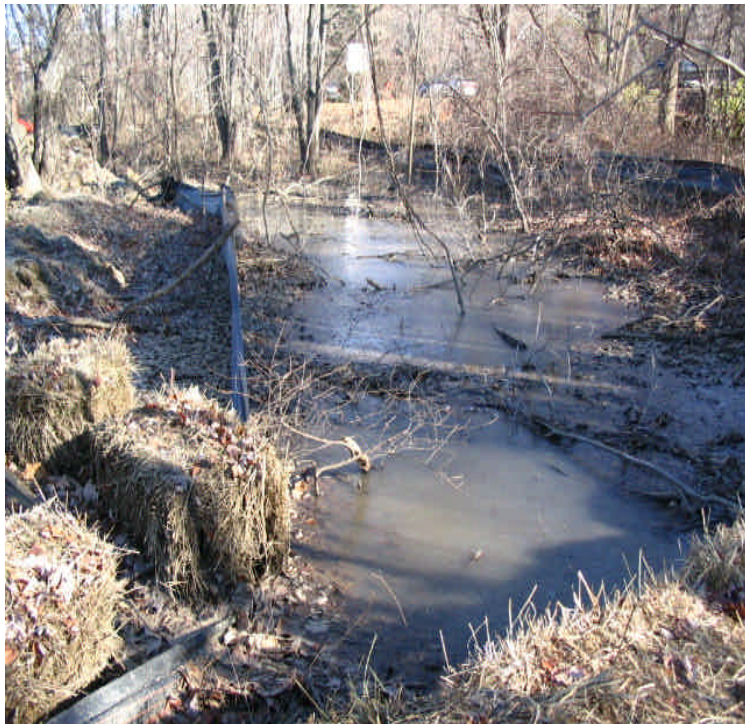
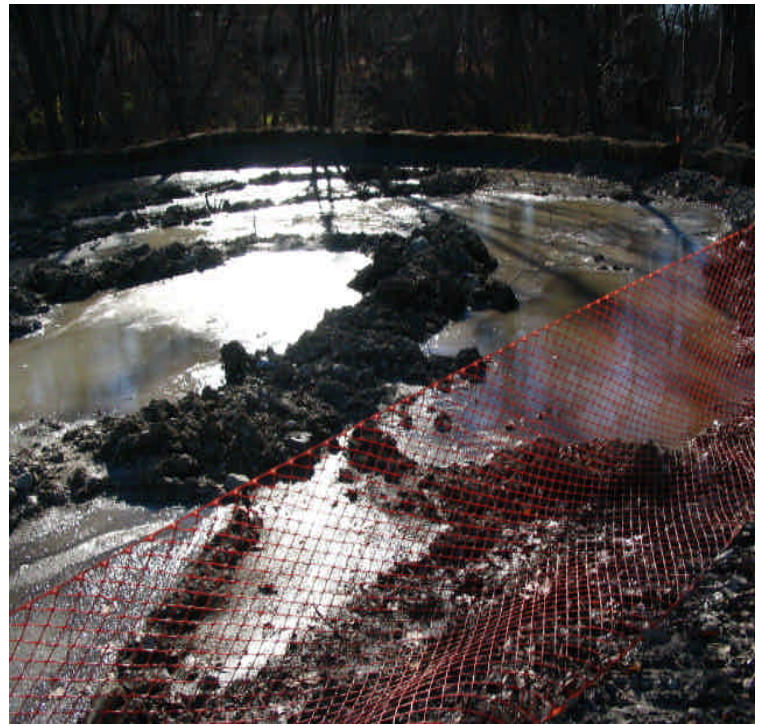
345kV (HDD): Photo on the left shows the additional pooled area to the east of the basin which has received some turbidity. Erosion controls were installed to encompass this area. Photo on the right shows an overview of the basin where standing water remains. 11/23/05

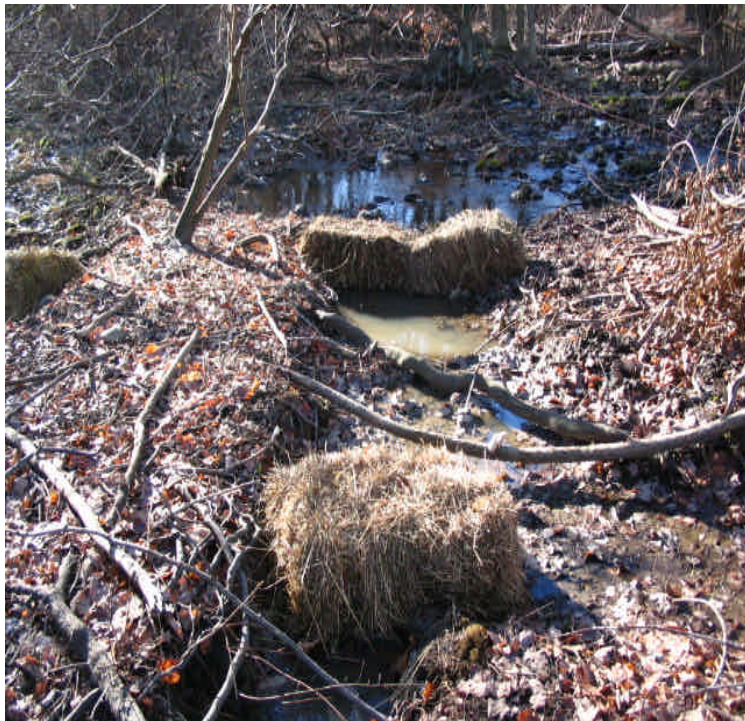
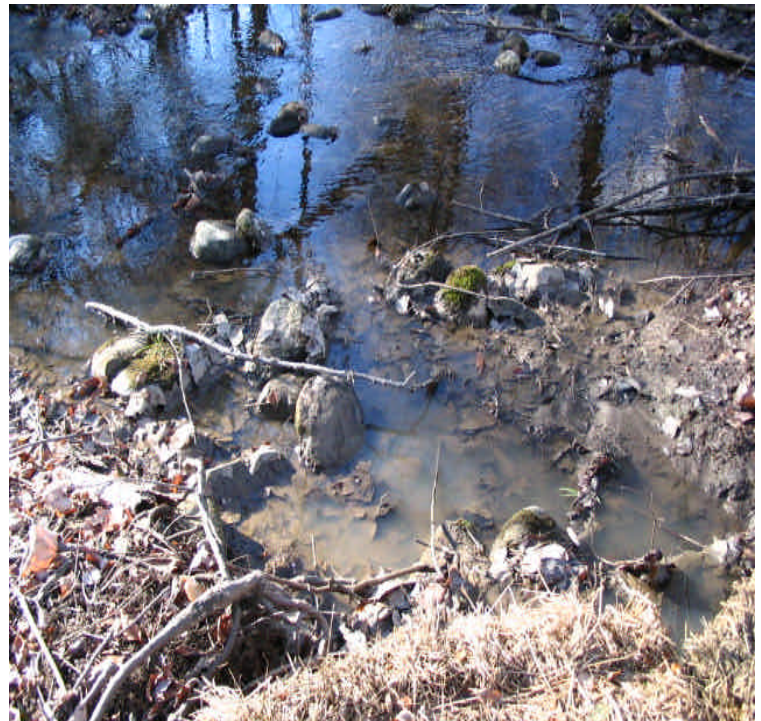
Photo on the left shows where haybale check dams were placed appropriately into the channels leading from the basin. Photo on the right shows that the haybales are helping to filter some of the turbidity but minor amounts are still getting through. 11/23/05

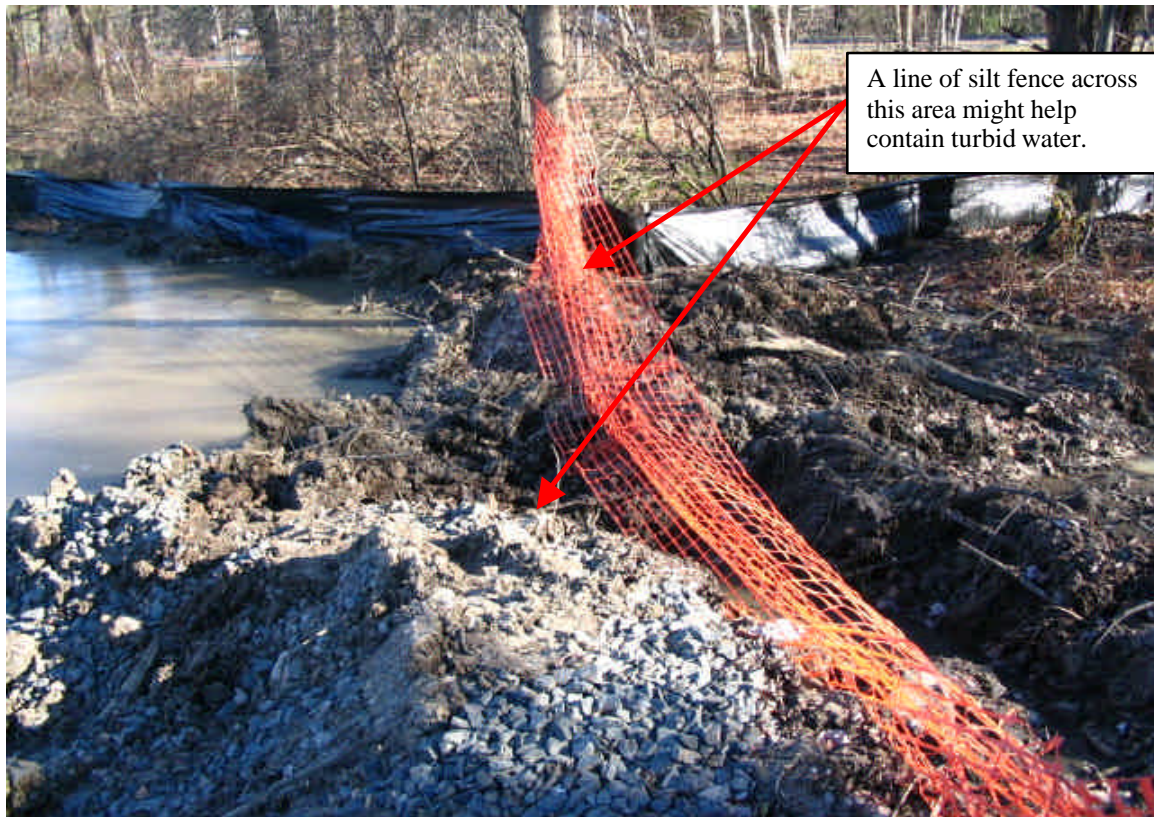
Photo shows where additional silt fence was added to the east of the site as recommended but turbid water is still pooling up in this area. Silt fence across the area between the existing fence and the existing stone berm of the basin may help. 11/23/05

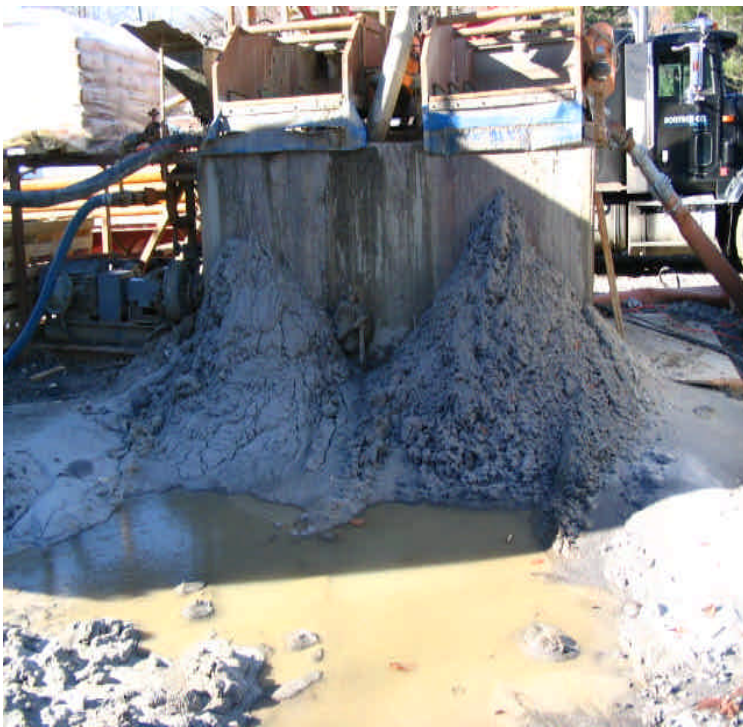
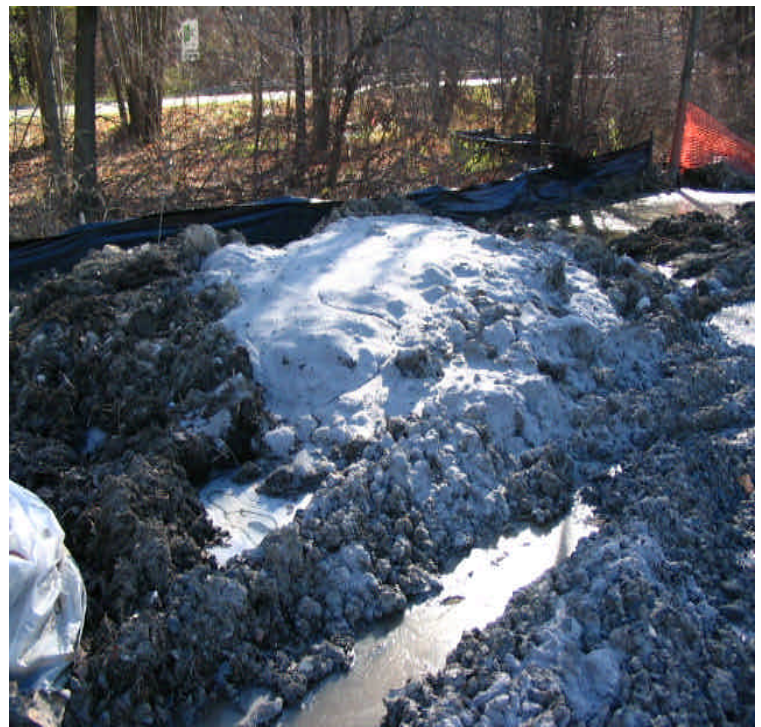
Photo on the left shows piles of drilling mud accumulating near the tanks on site. Turbid water running off from here is part of the issue. Photo on the right shows where a pile of drilling mud has been noted near the silt fence for several weeks. 11/23/05

Areas of Inspection	Observation	Recommended Action
Spills and Material Storage	- A pile of drilling muds was noticed accumulating below the tanks and piled against the silt fence at the HDD site. The leaks seem to have continued and turbid water was also noted here. 11/23/05	-Determine what is causing the overflow/loss of muds and contain them. Remove the piles that have formed and attempt to remove additional water from the basin. 11/23/05
